THE MABLE HOUSE

Mableton, Georgia

Historic Structure Report

Conservation of Historic Building Materials Class
Heritage Preservation Graduate Program
Georgia State University

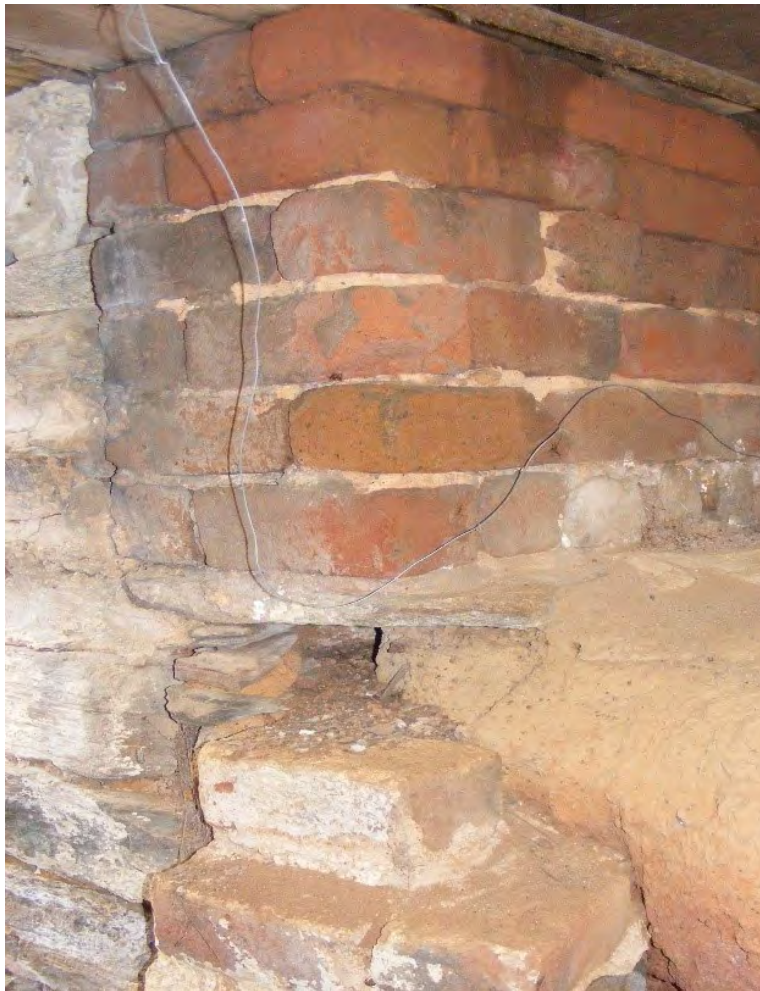
The load-bearing brick foundation is three wythes thick (averaging at 12'-3/4") and set above a granite damp course. On the exterior the brick is parged with Portland cement based stucco and averages from 1' to 1'-6" above ground. Along the west and east walls are four 16" openings for ventilation that have historic wood strips nailed into the sill above and notched board below with machine cut nails on the interior, intended to keep larger animals out of the basement. In the twentieth century, these openings were infilled with a one wythe thick course of modern cored brick. Working metal vents were also added. The porches on the west and south facades are historic and the foundation extends outwards to support the deck. The porch on the east facade is not historic, and the 10'-7-1/8" opening along the foundation has been filled in with concrete masonry units.

Figure 19. (Photo 13) View of foundation

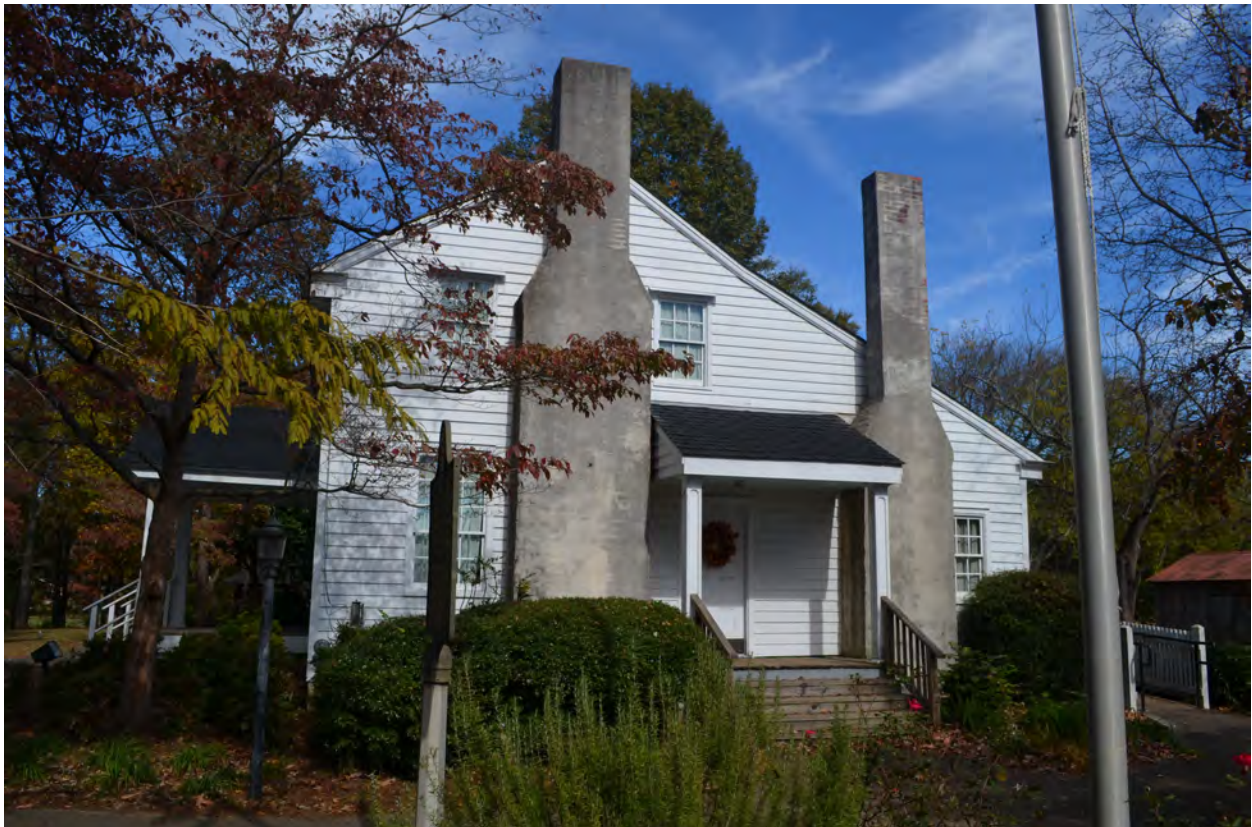
The south façade extends at a 5:12 pitch from the two-story section of the house to the one-story section on the rear. The window on this section of the façade is six-over-six replacement wood sash. A similar parged brick chimney separates the window from the shed-roofed porch. The southwest chimney is $\frac{1}{4}$ " over 4' out of plumb to the south at the base. The flue encasement is $\frac{1}{4}$ " over 4' out of plumb to the south. The southeast chimney is $\frac{1}{4}$ " out of plumb to the south at the base and the flue encasement $\frac{1}{4}$ " over 4' out of plumb to the east.

Figure 22. (Photo 15) View of south façade

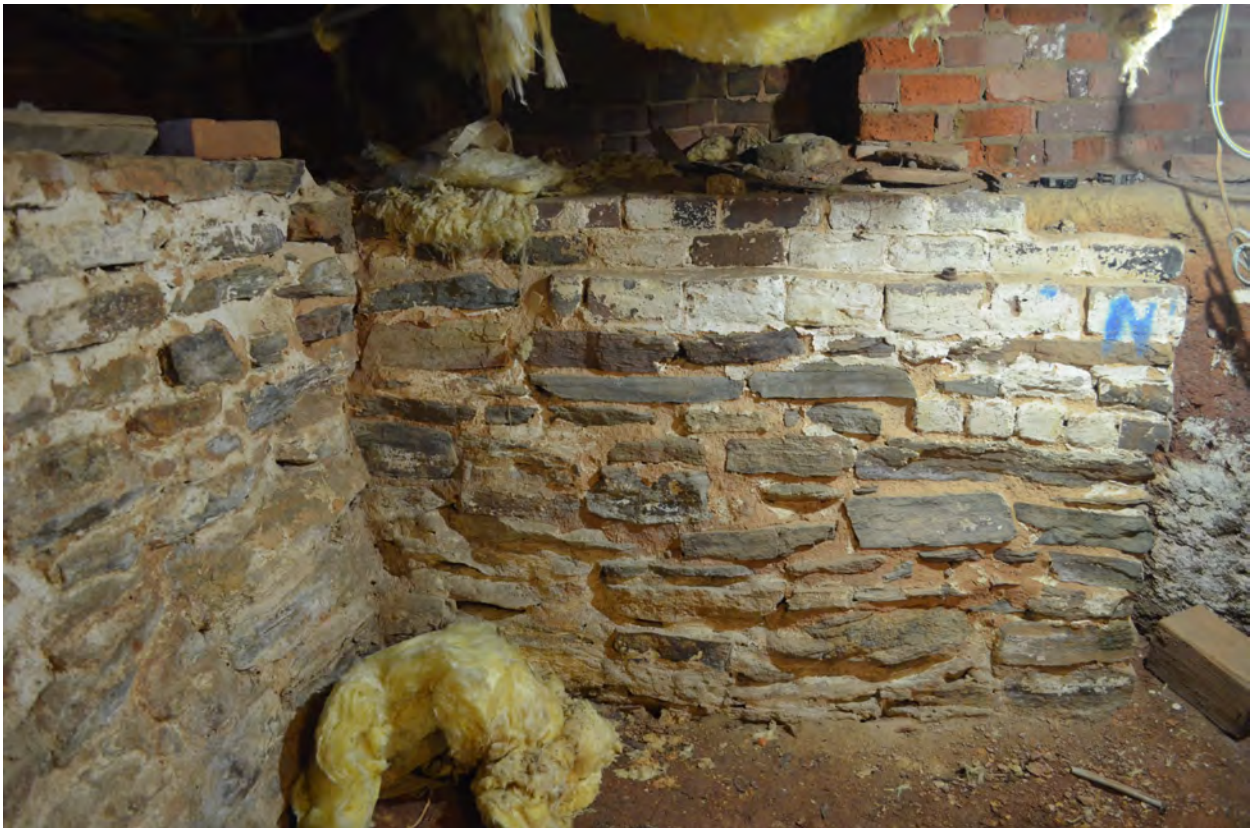
Figure 31. (Photo 21) North and west walls of dugout basement, constructed with field stone and historic brick and previously whitewashed

wall is shorter, approximately 3' 10 ½". The walls have been previously whitewashed, indicating use as a functional space,⁷¹ likely food storage as a root cellar (Figure 31, Photo 21).⁷²

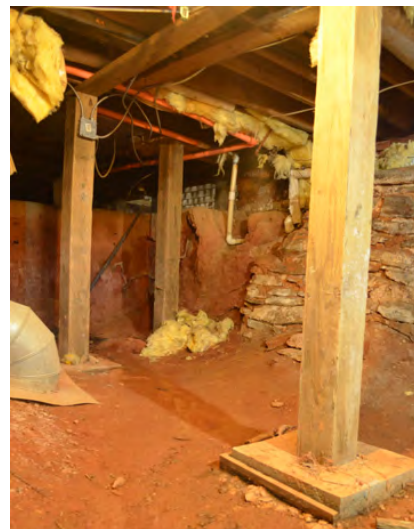
Figure 32. (Photo 22) Modern 6" x 6" wood posts on modern concrete footers support floor joists

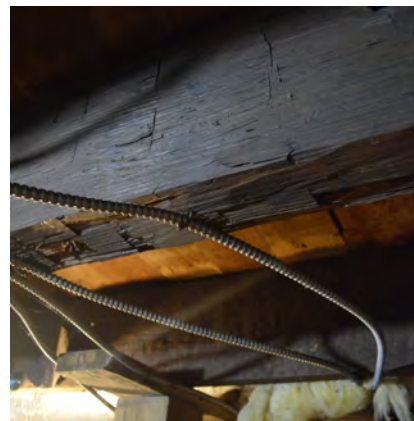
The framing for the first floor is exposed and visible in the basement. Hand-hewn sills (11 ½" x 9 ½") sit atop the brick pier foundation (Figure 33, Photo 23). Primary joists (9 ¾" x 4 ½") and reciprocating sawn secondary joists (9 ¾" x 2") extend from the center beam and run east to west. The joists are spaced approximately 24" on center. There is no subfloor; the flooring above sits directly on the joists.

Figure 33. (Photo 23) Framing for first floor and original hand hewn sills visible from basement

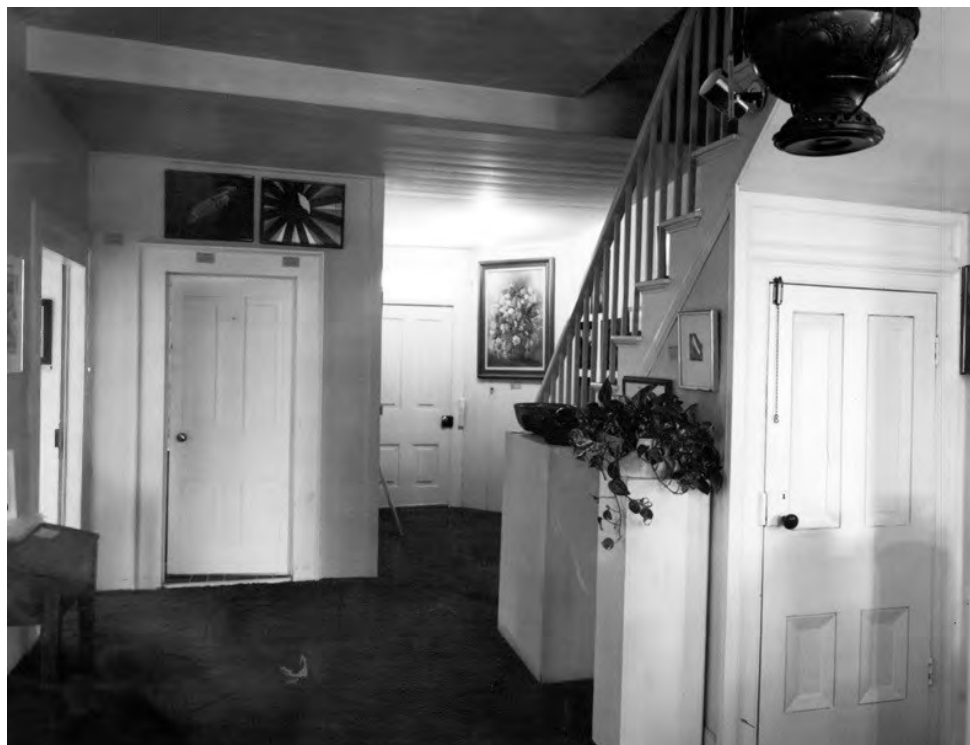
Figure 38. Room 101 facing east showing where bathroom was once installed but later removed, photo by James R. Lockhart in 1986

on the interior and raised panels in the exterior. A photograph from the 1986 National Register of Historic Places nomination shows that a single leaf door was once present on the east wall of 101 (Figure 38). Both sets of double doors have four panels and rectilinear, six light transoms. Only the west double doors (D1) features sidelights.

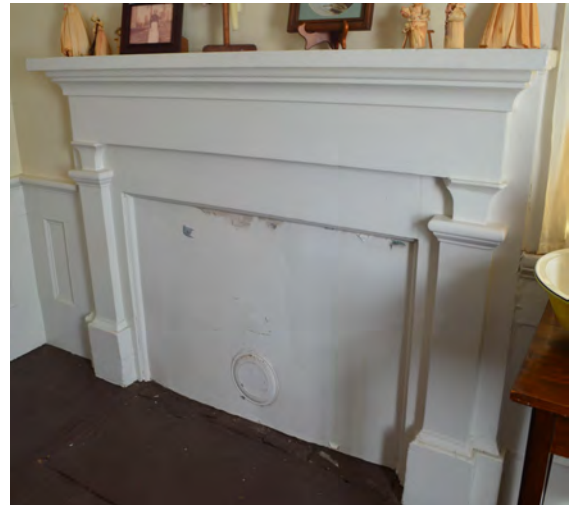
Figure 45. (Photo 33) Sealed firebox in Room 105

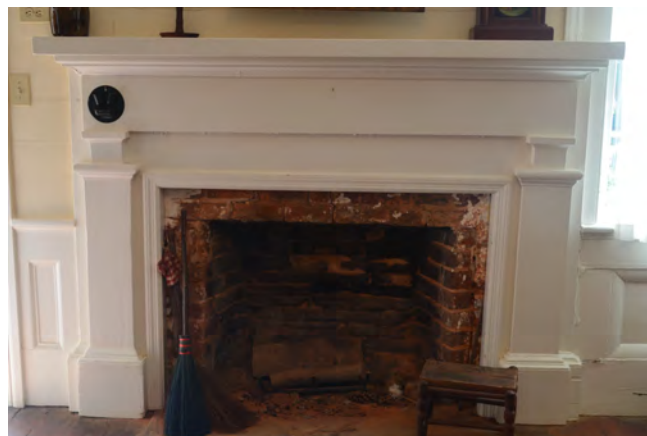
Figure 46. (Photo 34) Added white trim to the front façade of the firebox in Room 102

Room 102 is the only Fireplace surround to be altered; a thin wood frame was added to the front of the brick firebox (Figure 46, Photo 34). Rooms 102, 104 and 202 are the only fireplaces that have brick fireboxes; all the others have been sealed off. Another key difference is that the fireplace surrounds and mantels on the second floor in Rooms 202 and 203 are the smallest out of all the others in the house. They also have thinner and simpler mantels and pilasters that are missing the sprouting capitals found on the other fireplace surrounds (Figure 47, Photo 35).

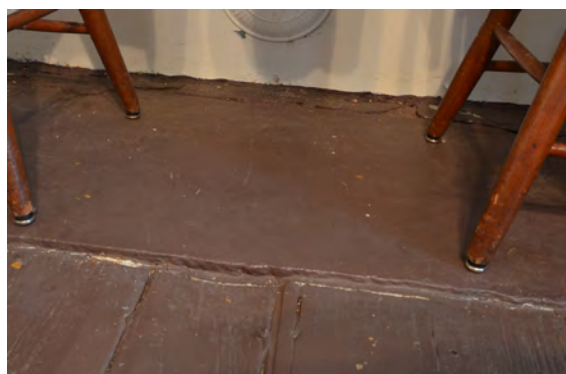
The floor is currently stained an amber color in all of the rooms except for those at the back of the house, rooms 104 and 105 and those on the second, rooms 202 and 203; those have been painted a dark brown (Figure 50, Photo 38 and Figure 51, Photo 39). The interior of the house, however, remained unpainted until 1942. There is a “witness” panel that demonstrates what the house looked like before it was painted. (Figure 52, Photo 40). Also evident from the interior of the staircase closet, the floor was most possible once painted an ochre color (Figure 53, Photo 41).

Figure 51. (photo 39) Painted dark brown floor near the fireplace on the north wall in Room 105

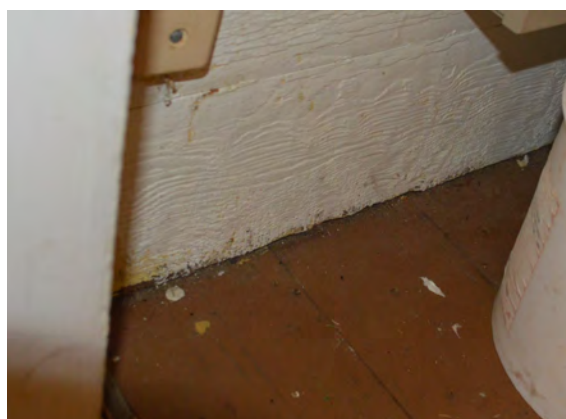
Figure 53 (Photo 41) Room 101, the interior of the staircase closet shows an ochre painted floor.

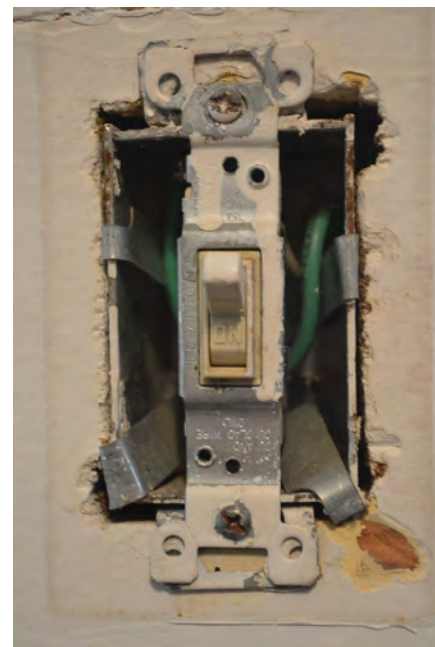
Figure 59. (Photo 47) Paint analysis performed on the exposed wall switch on the north wall near the hall parlor door.

The walls are painted white in the central hall; however, a paint analysis done behind a light switch revealed that the wallboards in the past were painted a yellow color (Figure 59, Photo 47). On the ceiling are three sprinklers from the house's fire suppression system, a security system, two electric lights that are non-historic, and cloth wiring above the back entry doors. Ghost marks of the bathroom (installed in 1942 and removed later when the building was turned into a house museum) can be seen near the same back door. Marks from a 6" beam reveal that the bathroom wall was about 7' wide and 5' long and stopped at the beginning of the bedroom door on the north wall. The same 1986 National Register of Historic Places nomination photograph of the Mable House showed a single back entry door on the east wall.

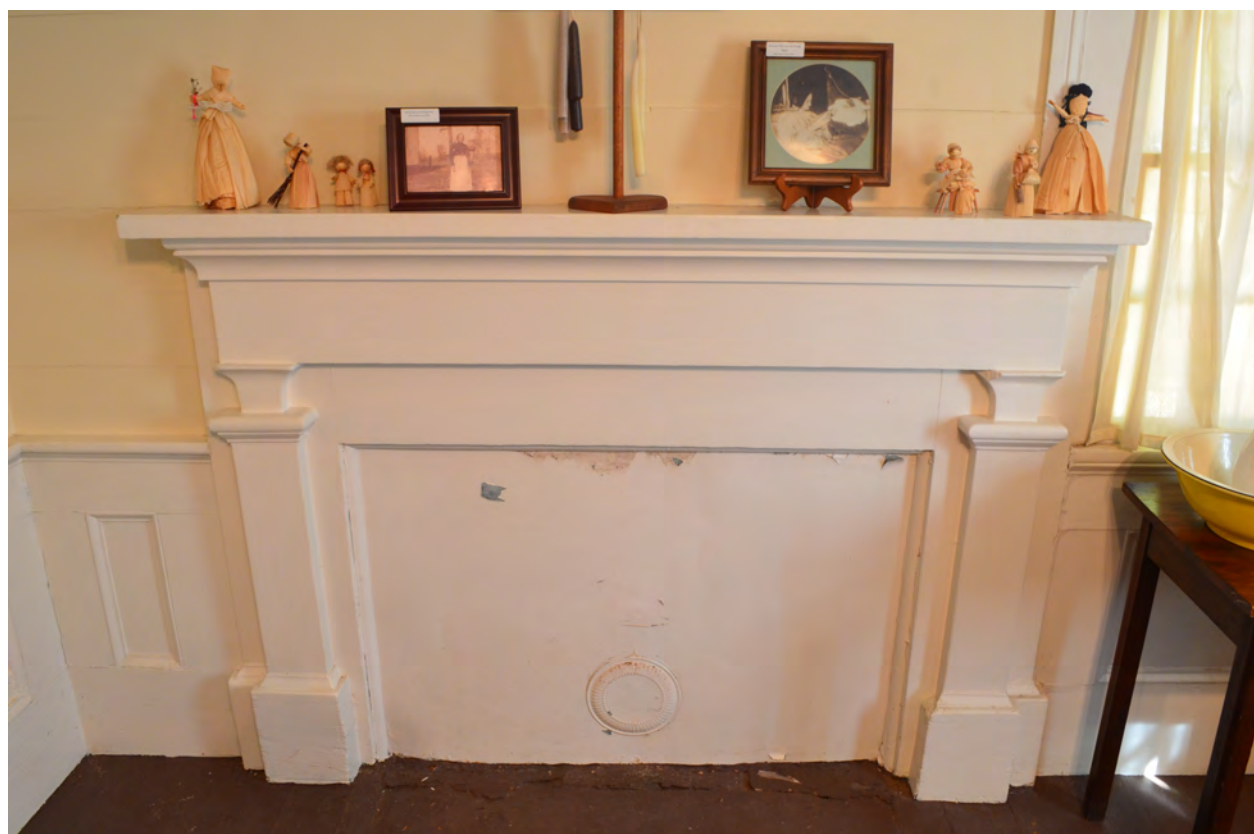
Figure 67. (Photo 55) Room 105, pilaster mantle with sealed opening

Room 105 features a similar pilaster mantel as seen in room 102. Rather than the open fireplace seen in room 103, the opening in room 105 is sealed off from the exterior with a board. (Figure 67, Photo 55)

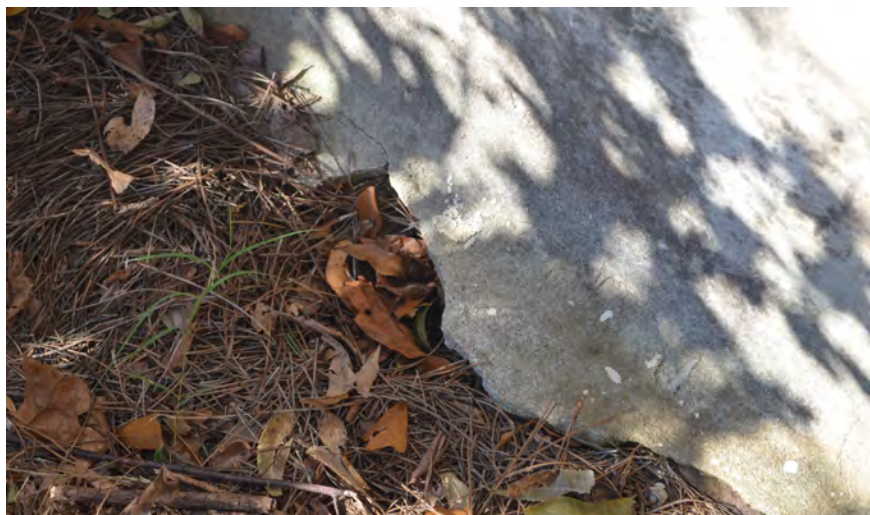
A six-inch hole is located at the base of the foundation on the northern corner, and cold air can be felt coming up from the basement (figure 117, photo 100).

Figure 117. (Photo 100) Hole on northeast corner of east facade that opens to the basement

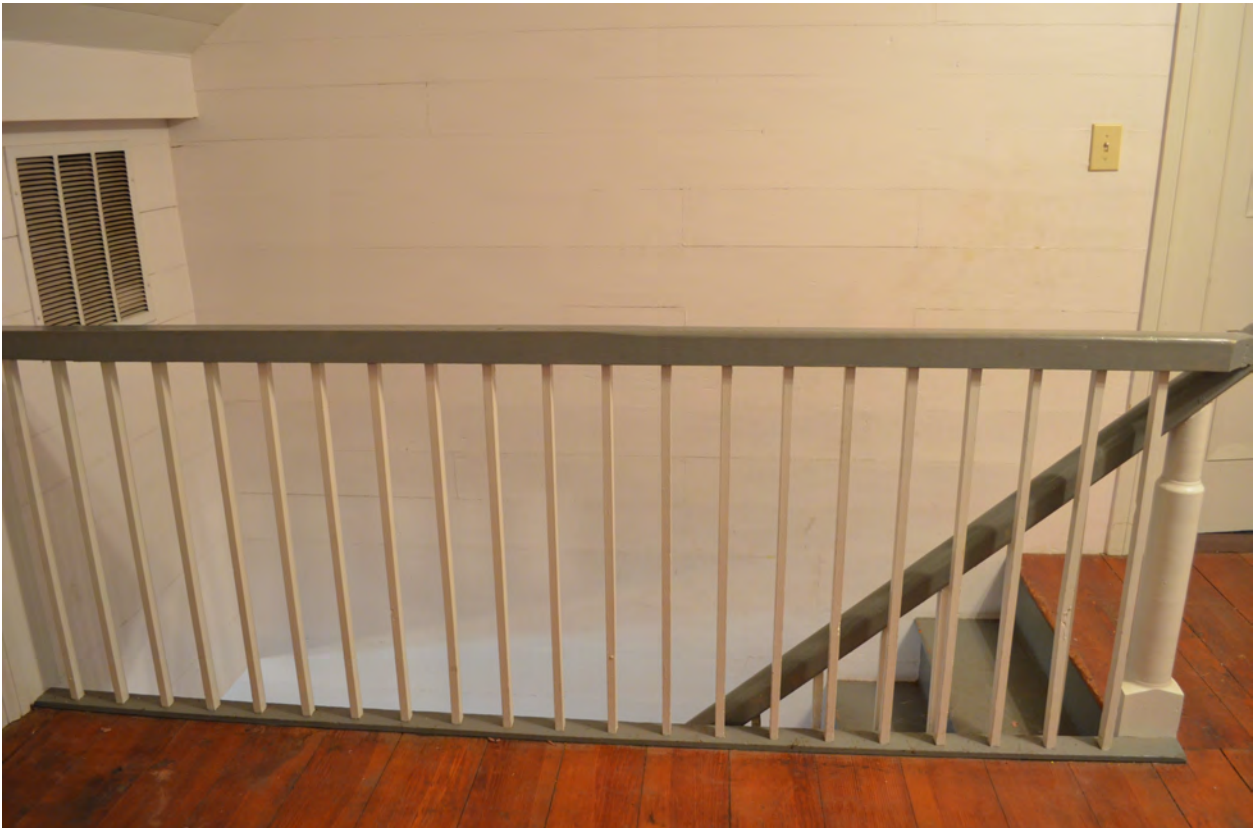
Figure 76. (Photo 63) Room 201, staircase along south wall showing simple square balustrades and turned detail on newel post

floor from the flight of stairs. (Figure 76, Photo 63). The balustrades are painted white, square-cut wood, while the handrail is rounded and painted gray. The newel post is turned.

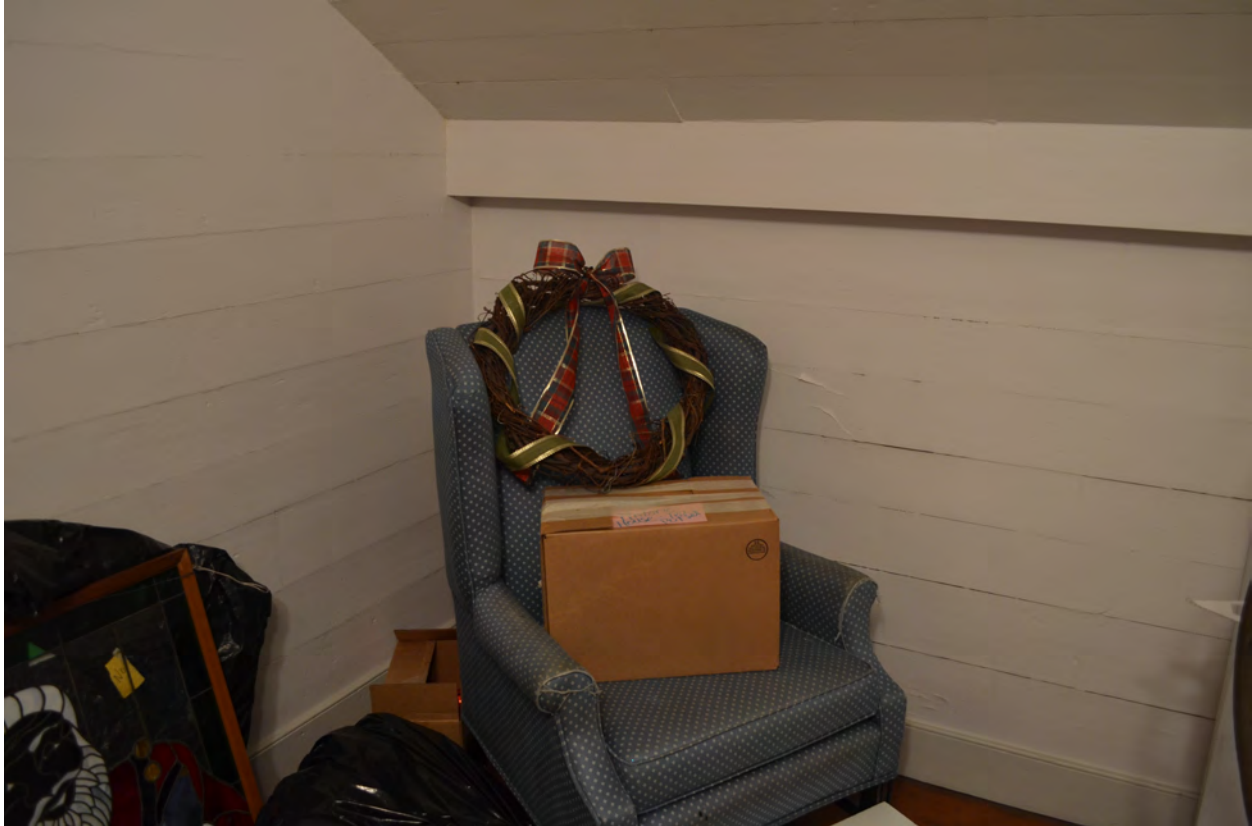
Figure 77. (Photo 64) painted ceilings slope on the east and west sides, allowing for the pitch of the roof, but is flat in the center

The tongue and groove, painted ceilings slope on the east and west sides, allowing for the pitch of the roof, but is flat in the center (Figure 77, Photo 64). The ceiling has a modern light fixture as well as sprinkler heads.

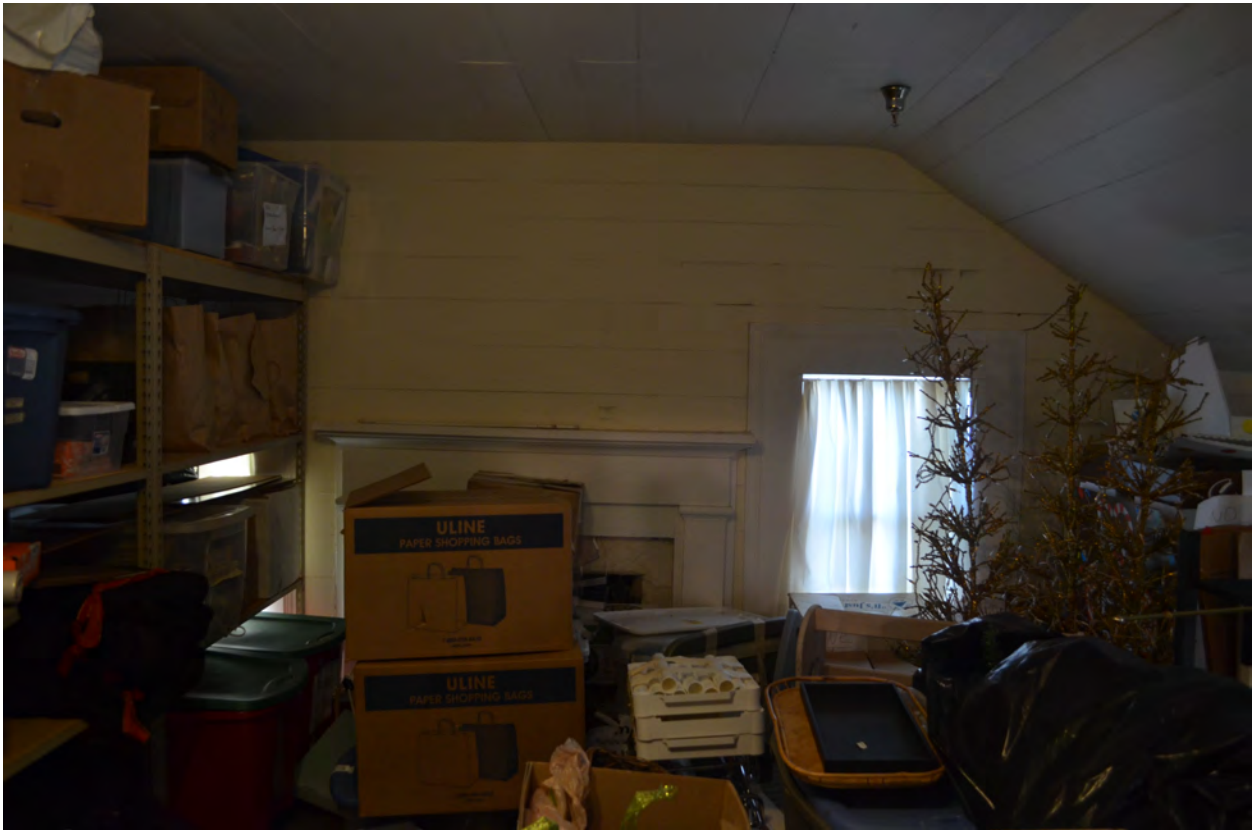
Figure 78. (Photo 65) Room 202, looking south

On the second floor, to the south of the staircase and hall, is room 202 which measures approximately 19' x 19' with a ceiling height of 7'-8-13/32" then it angles out at 40 degrees for 4'-10 3/8" to a height of 4'-9 5/8" at the top of the partially revealed plate (Figure 78, Photo 65). D11, the entry door, has a rim lock with a black knob. There are four windows in the room: residing on either side of the fireplace on the north wall is W18 and W19, and on the east wall are W20 and W21 which are flush with the floor (Figure 79, Photo 66).

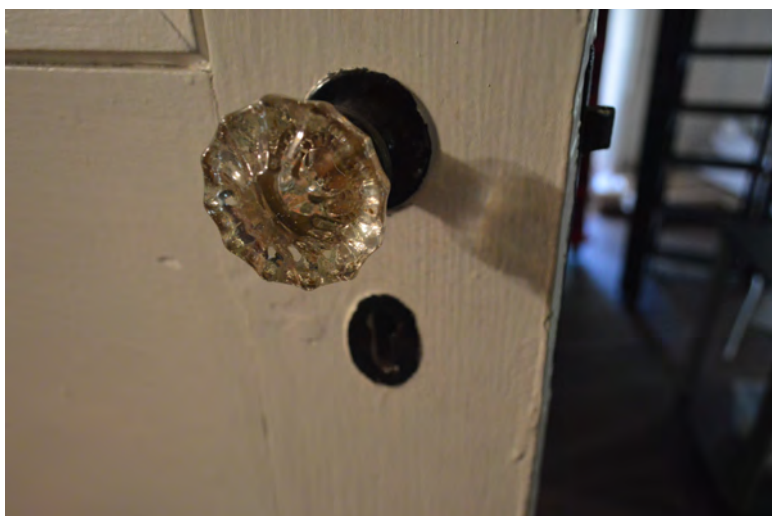
Figure 80. (Photo 67) Glass doorknob entering room 203 from 201

Like the other rooms in the Mable House, this room has tongue and groove flooring, walls, and ceiling. The entry into room 203 is a four-panel door with a glass doorknob (Figure 80, Photo 67) and metal rim lock, similar to the locks seen on the first floor.

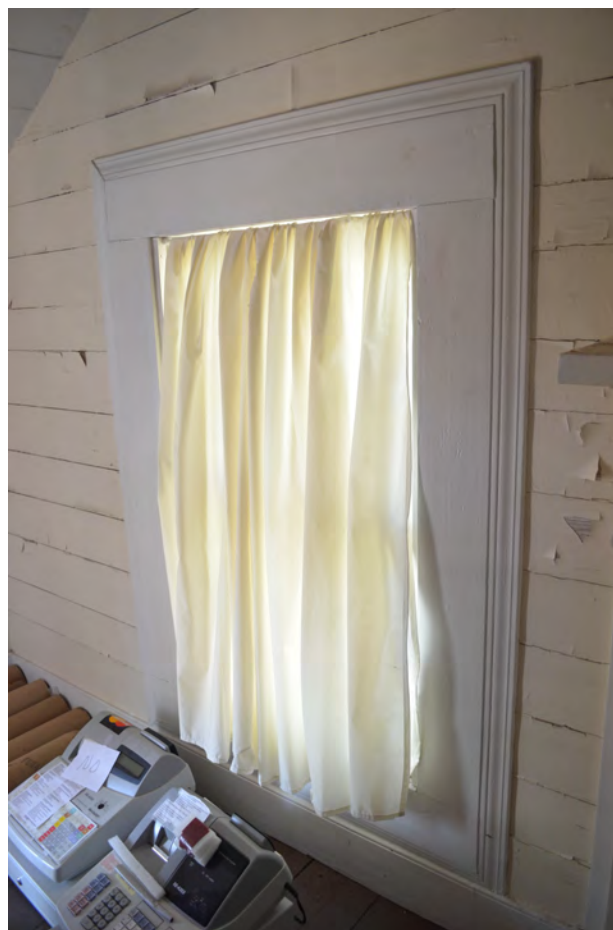
On the west wall of room 203 are two fixed windows (W14 and W15), which are directly on the flooring, as seen in room 202. The two double hung windows on either side of the north wall (W16 and W17) are surrounded by white painted trim and are dressed with single curtain panels. (Figure 81, Photo 68). It is unknown when these modern windows were installed.

Figure 81. (Photo 68) The two double hung windows on either side of the north wall (W16 and W17) are surrounded by white painted trim and are dressed with single curtain panels

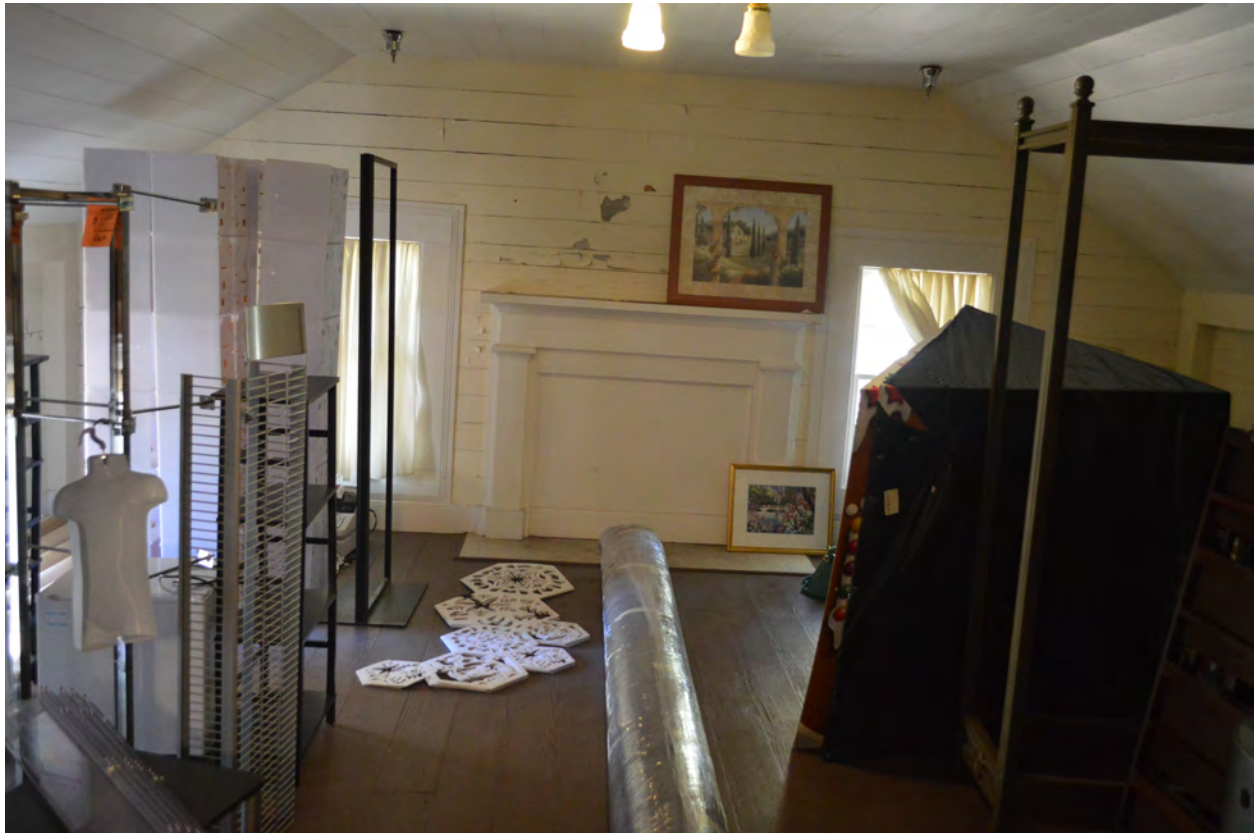
Figure 82. (Photo 69) Room 203, currently being used as storage

The fireplace of this room features a wood pilaster surround, stone hearth, and is closed to the exterior with a board (Figure 82, Photo 69).

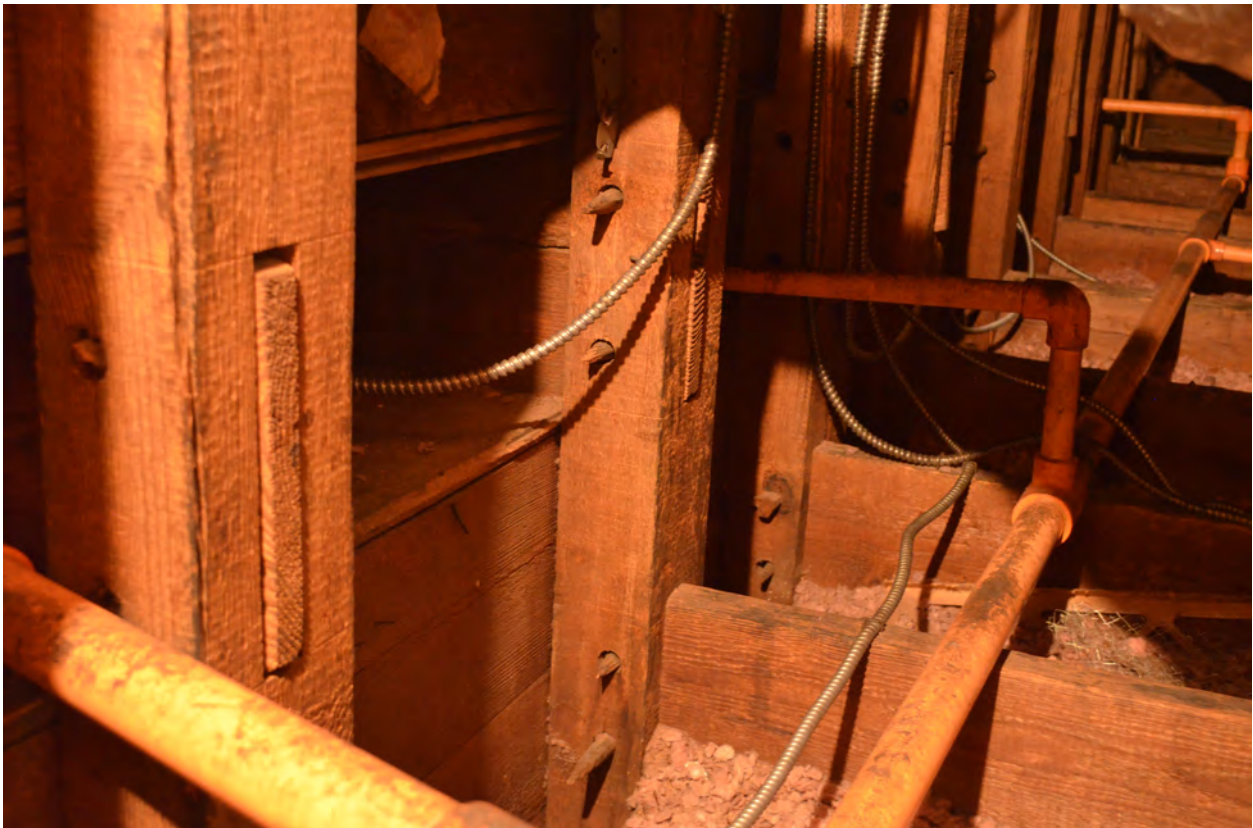
The framing is exposed in Room 204, allowing for an understanding of how the building was put together. Large studs (4" x 6" and 7 ¼" x 9 ¼") support the floor and ceiling joists, which are joined with pegged mortise and tenon (Figure 84, Photo 71). These features are indicative of brace frame construction, a variation of traditional timber frame construction.⁷³

Figure 84. (Photo 71) First floor ceiling joists visible from room 204, Large studs support the floor and ceiling joists, which are joined with pegged mortise and tenon

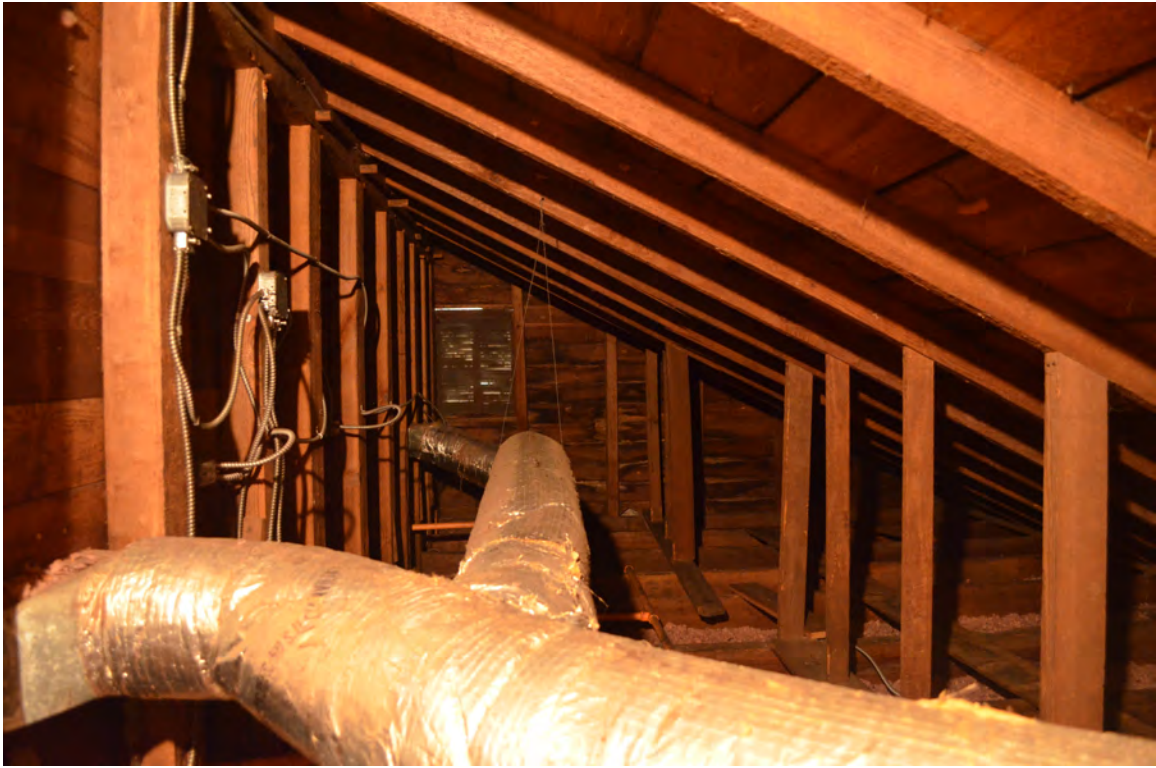
Figure 85. (Photo 72) Lowered vent and exposed weatherboard on the north gabled end house appears to be historic

The first floor ceiling joists are exposed in Room 204. The wood joists (9 ½" x 2") sit on the top plates of the first floor walls. The wood rafters (3 ¾" x 2") form a 5:12 pitch. There are vertical braces of varying dimensions supporting the rafters. A louvered vent sits in the north gabled end of the house. The exposed siding on the north gabled end appears to be historic (Figure 85, Photo 72), while several weatherboards on the south gabled end appear to be modern replacements (Figure 86, Photo 73).

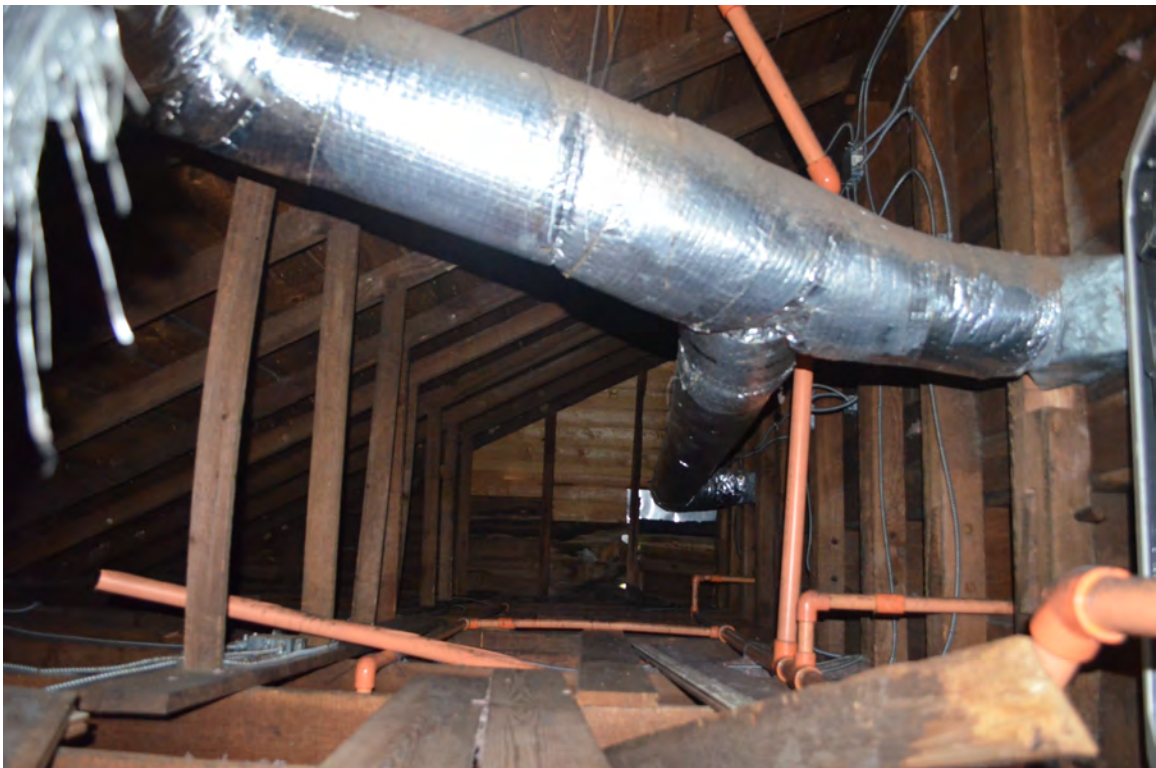
Figure 86. (Photo 73) Weatherboards on the south gabled end appear to be modern replacements

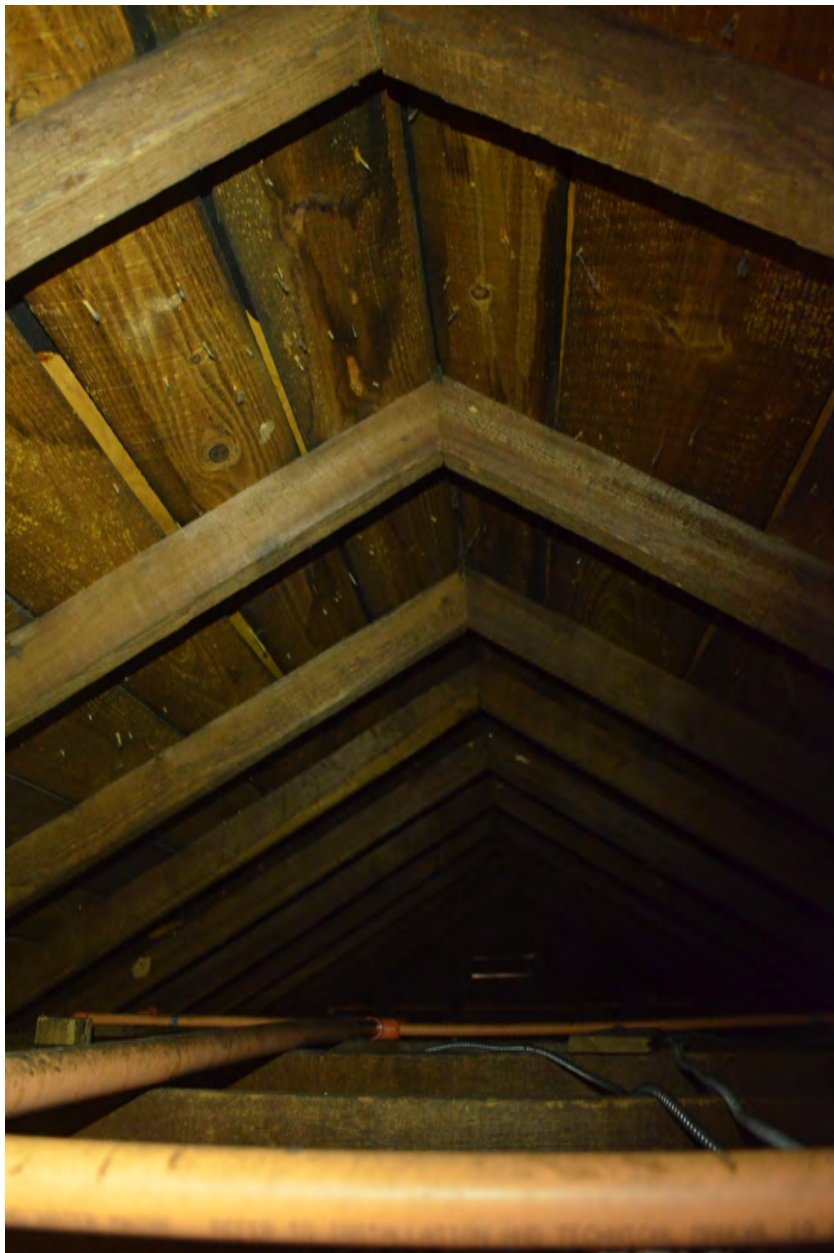
Figure 88. (Photo 74) Looking south, Rafters in room 301; no ridge board or joinery at peak

there any joinery or fasters where the rafters meet; they are mitered and simply rest upon each other (Figure 88, Photo 74). The main roof is a 7:12 pitch. There are two modern vents penetrating the east side of the roof.

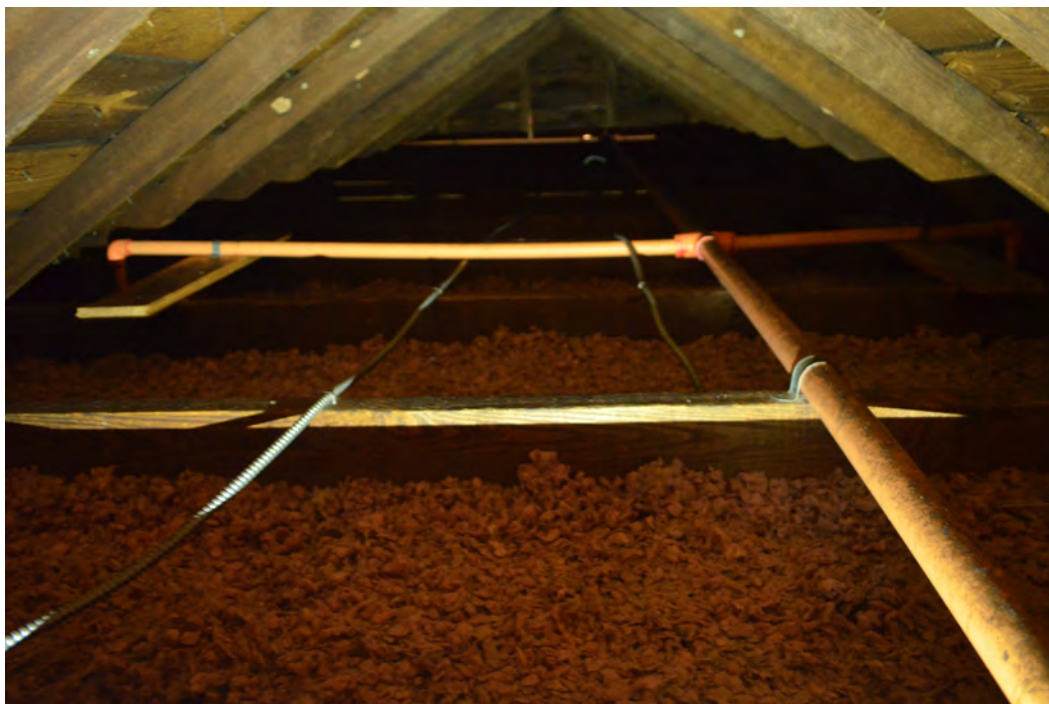
Figure 90. (Photo 75) Sprinkler system, modern electrical conduit, and fiberglass insulation visible in room 301.

first and second floors, and in both attic spaces, 204 and 301 (Figure 89, Photo 75). Each room has multiple sprinkler heads installed through the ceiling, as does the basement. There are smoke alarms on both floors of the building — none of which were functioning. There is no plumbing for water or sewer on the interior of the house. Only one exterior spigot, on the east façade, is functioning.
